MINE AND WELL EFFECTS EVALUATION

PROJECT RULISON

Open-file Report USBM 1002

March 1970

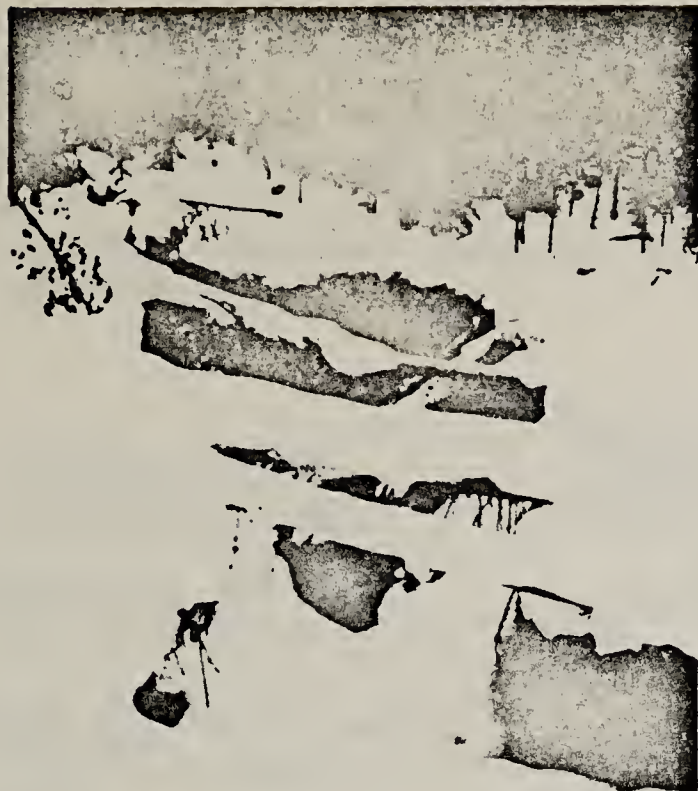
Carter mine Damages to the Carter and two other contiguous gold mines, consisting of caved adit portals in alluvium and caved drifts below old shrinkage stopes, also were reported as resulting from the Rulison event. (See figures 15 and 16.) An inspection revealed nothing conclusive that would tie this damage to Rulison. About all that could be determined was that it probably was of recent origin. The sections of the mines found damaged were those most susceptible to natural cave-ins. Considering the age of the workings, the conditions of the old timbers, and the altered nature of the Precambrian granite and schist wall rock, such cave-ins would be expected to occur periodically at any time. It was concluded that the damages reported were of natural origin and not related to the Rulison event.

Fig. 15 - Caved portal of No. 2
level of Golden Islet
mine.

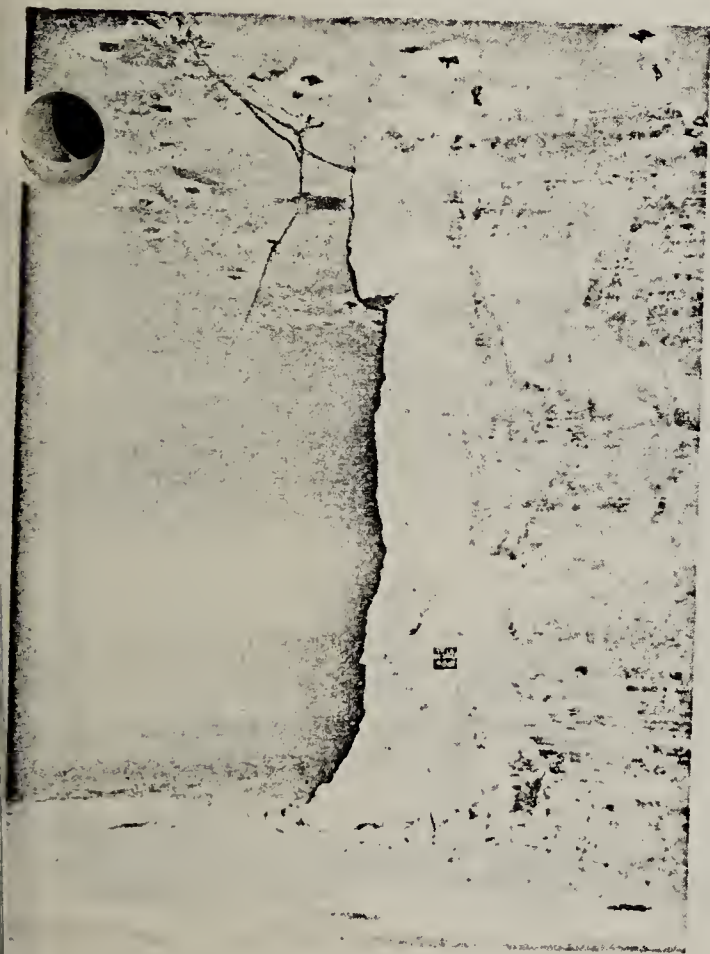
Fractured corners of 27-ft-high pillars along upper haulageway

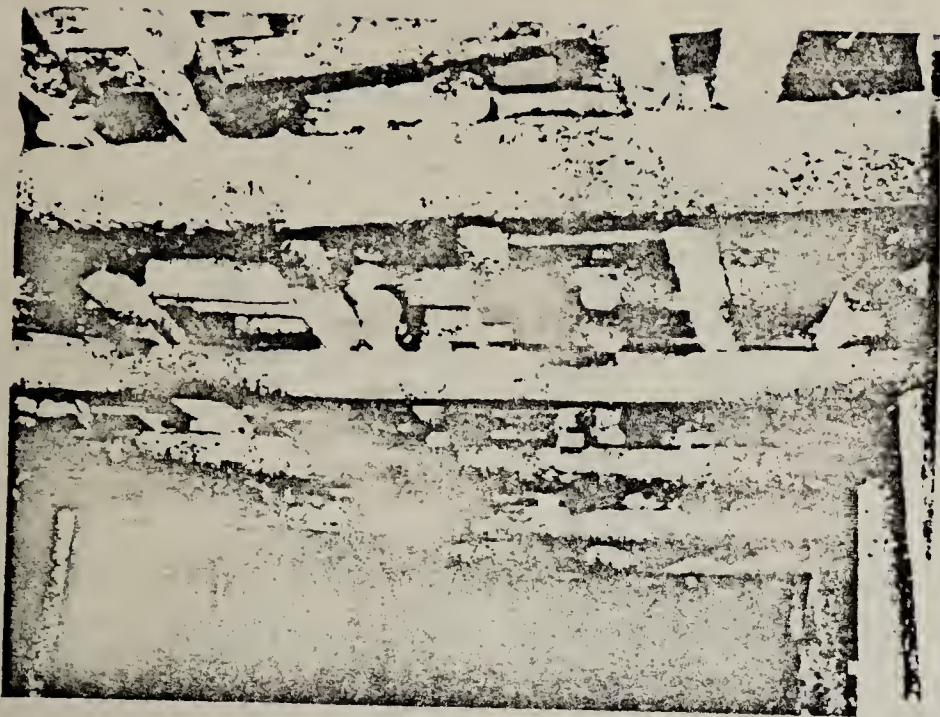
Timber crib in caved
alluvium along No. 2
Outside entry

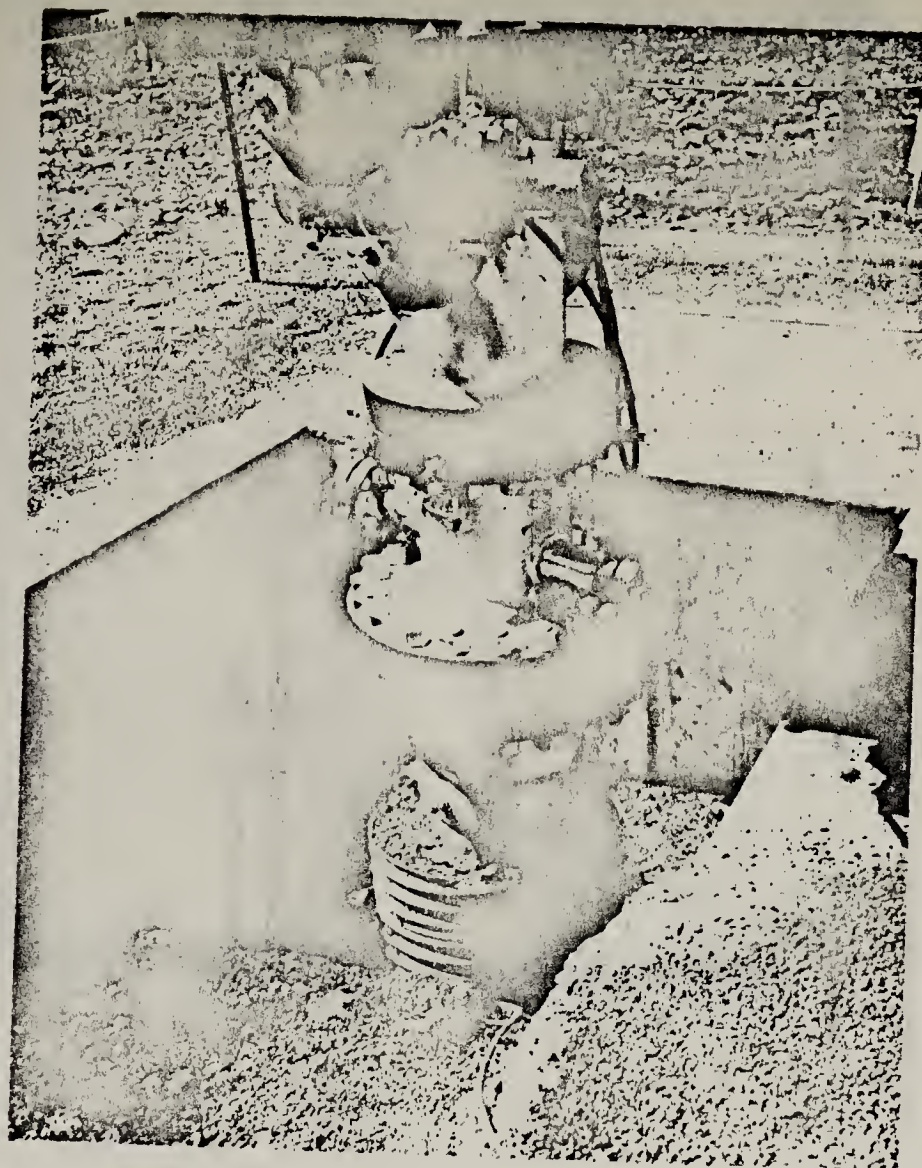
Photo 1 - Preshot

| 1-4 | <u>Emplacement Well R-E</u> (Ground Zero) - Only evidence of ground motion from event is space visible in photo 4, where earth fill has been displaced from 10 3/4-inch casing. |
